**Inspection Report**  
**Minerals Regulatory Program**  
September 8, 2005

**Mine Name:** Lakeview Quarry  
**Operator Name:**  
Lakeview Rock Products  
**Inspector(s):** Doug Jensen  
**Other Participants:** Russ Larson, Lakeview Rock  
**Mine Status:** Active

**Permit number:** M/035/020  
**Inspection Date** 9/ 8/2005  
**Time:** 8:00 AM

RE: Site Inspection, Lakeview Rock Products, Lakeview Quarry, M/035/020, Salt Lake County, Utah

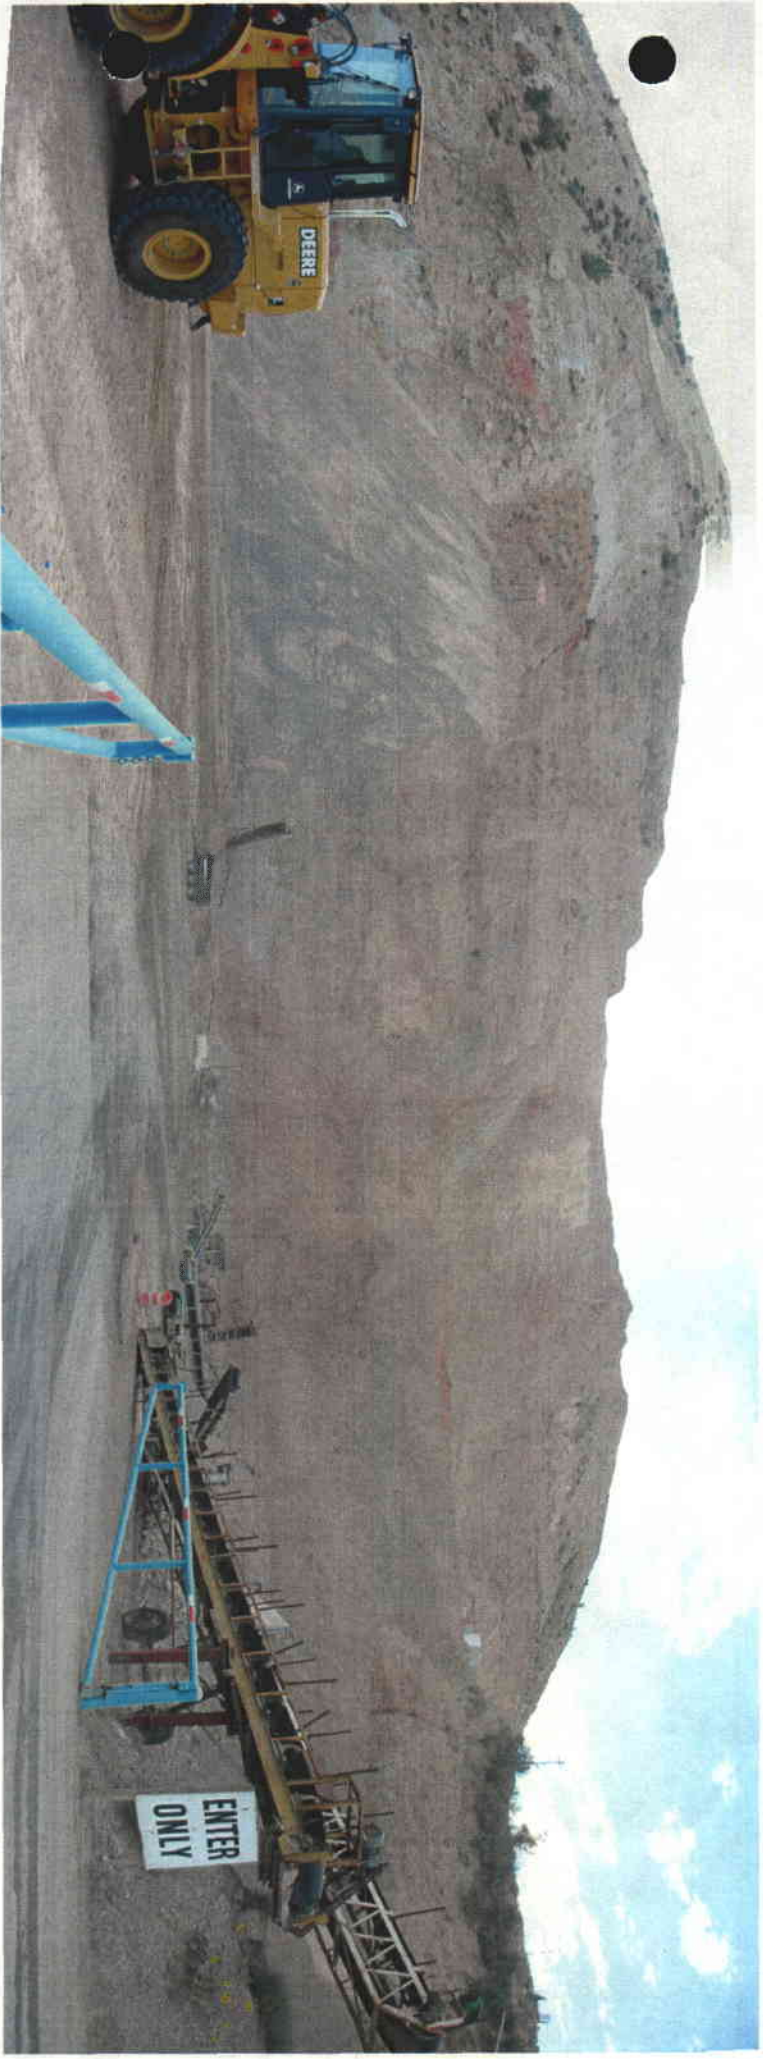
While waiting for Russ to arrive, I inspected the lower quarry area that Lakeview had recently moved a portion of their operations to. This is the area where Alroc had previously operated a SMO. There have been quite a few improvements since Lakeview began operating this lower site. All of the asphalt reject that had been located on this site has been removed and a new office/scale house has been constructed. A visual barrier (solid fence) and gates, to control the flow of traffic into the yard, have also been constructed at the site.

We drove to the area where Lakeview is interested in starting their new operation. The area of interest is an old pre-law quarry site called the Thomas Pit which is located several hundred yards to the north of their present operation. The floor of this site had been littered with garbage and old broken cement. Lakeview has cleaned up the surface material and disposed of much of it. Russ indicated that the previous operator of the Thomas Pit had excavated the floor of the pit area below

LAKEVIEW'S LOWER QUARRY AREA

PROPOSED THOMAS PIT AREA

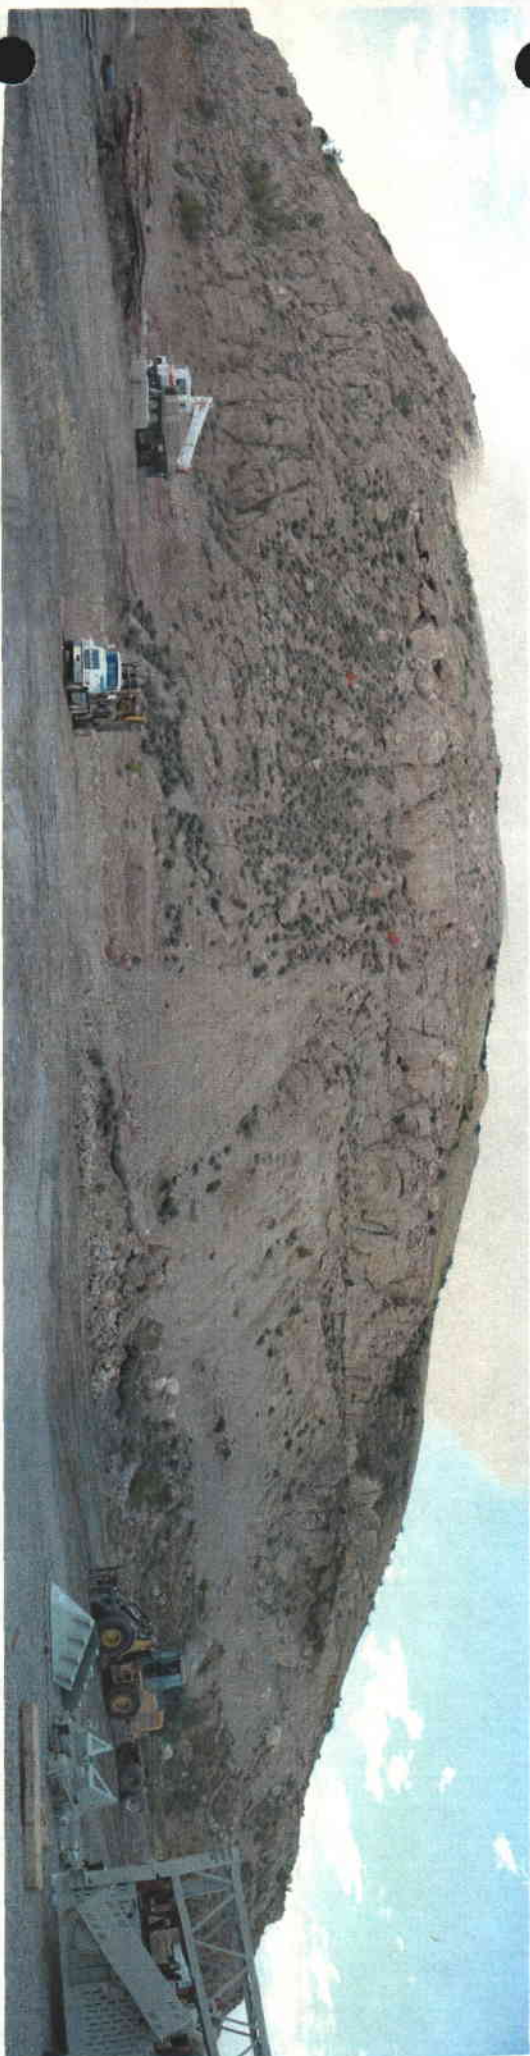
**THOMAS PIT GRADING PLAN**  
SCALE: 1" = 50'

Lakeview has been dealing with the city of North Salt Lake concerning the development of this quarry. Because the city envisioned housing in the future above the area where the pit would be excavated, they request a one hundred foot set back between the property line and the quarry benches. Russ provided me with a conceptual drawing of the final quarry configurations which is attached to this report.

Rather than delay the approval of Lakeview's present permitting effort, I recommended that they file the Thomas Pit as an amendment to their permit. Lakeview's permitting effort on their present operation is near approval and the addition of the Thomas Pit would only delay this process.

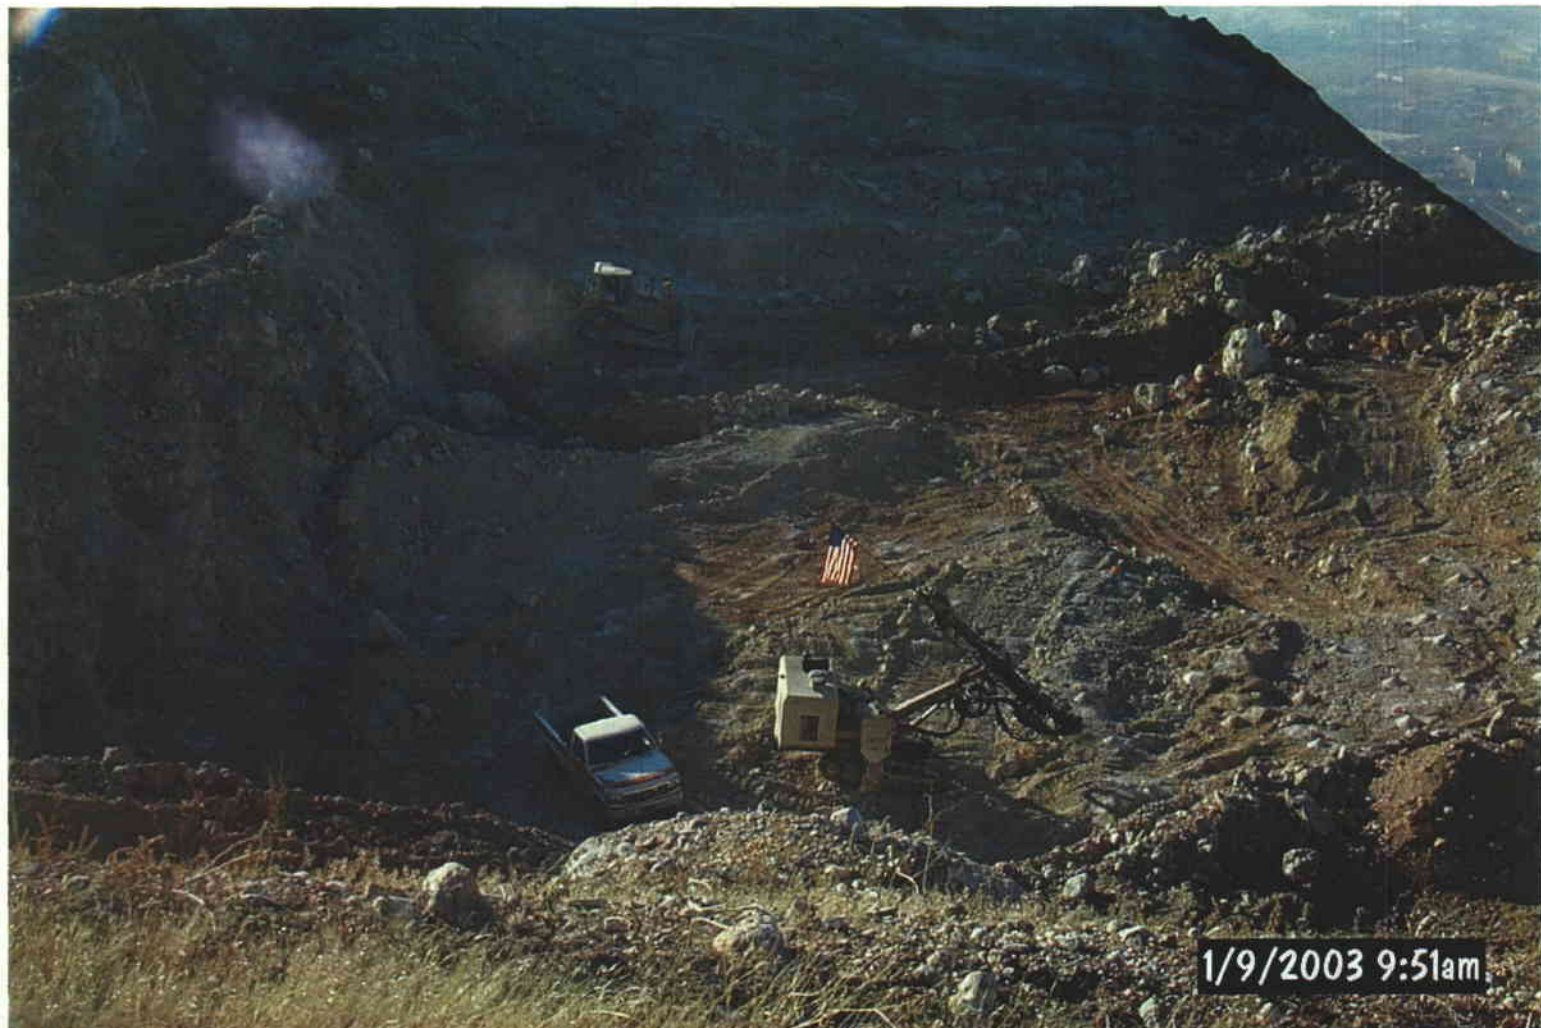
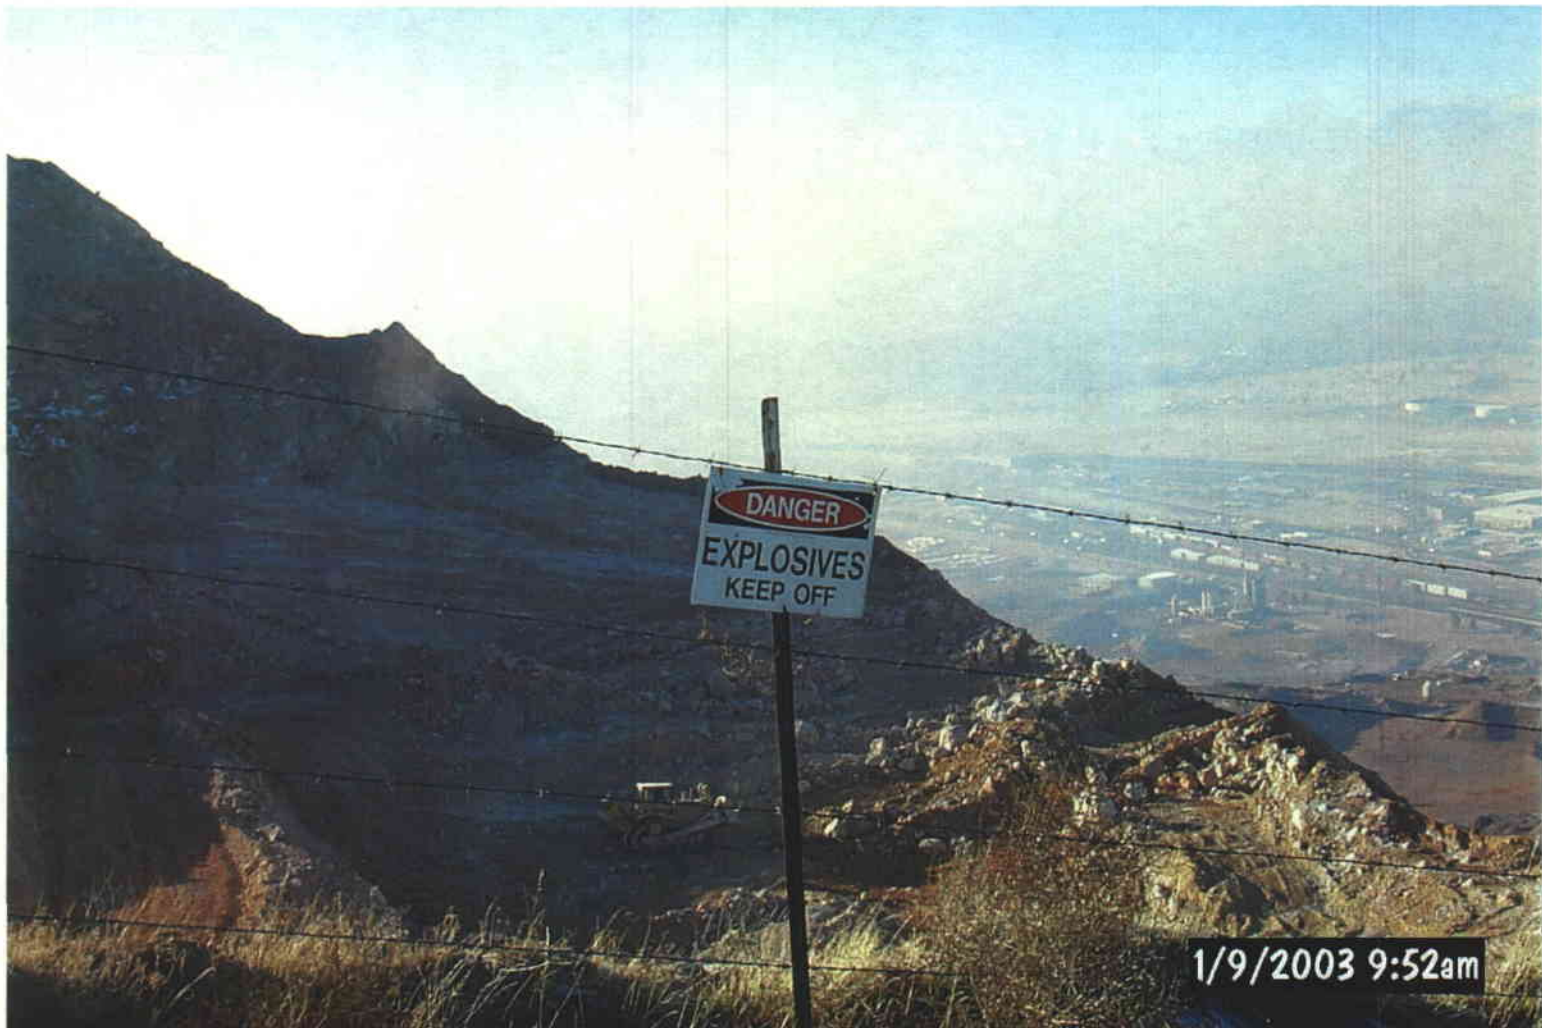
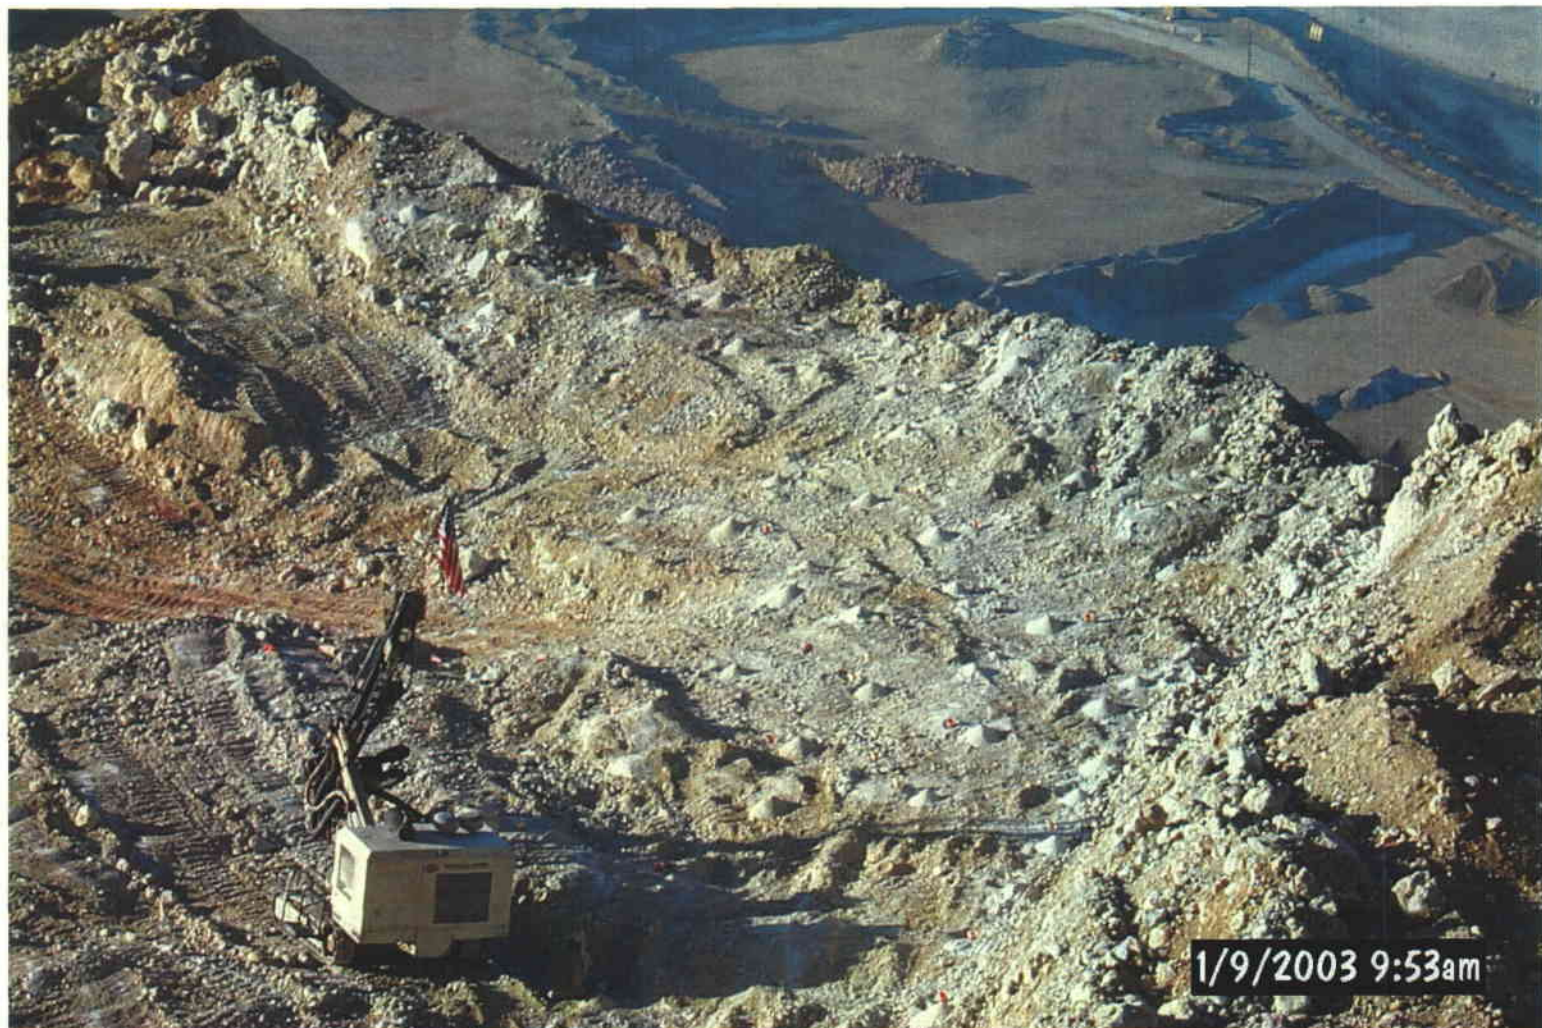
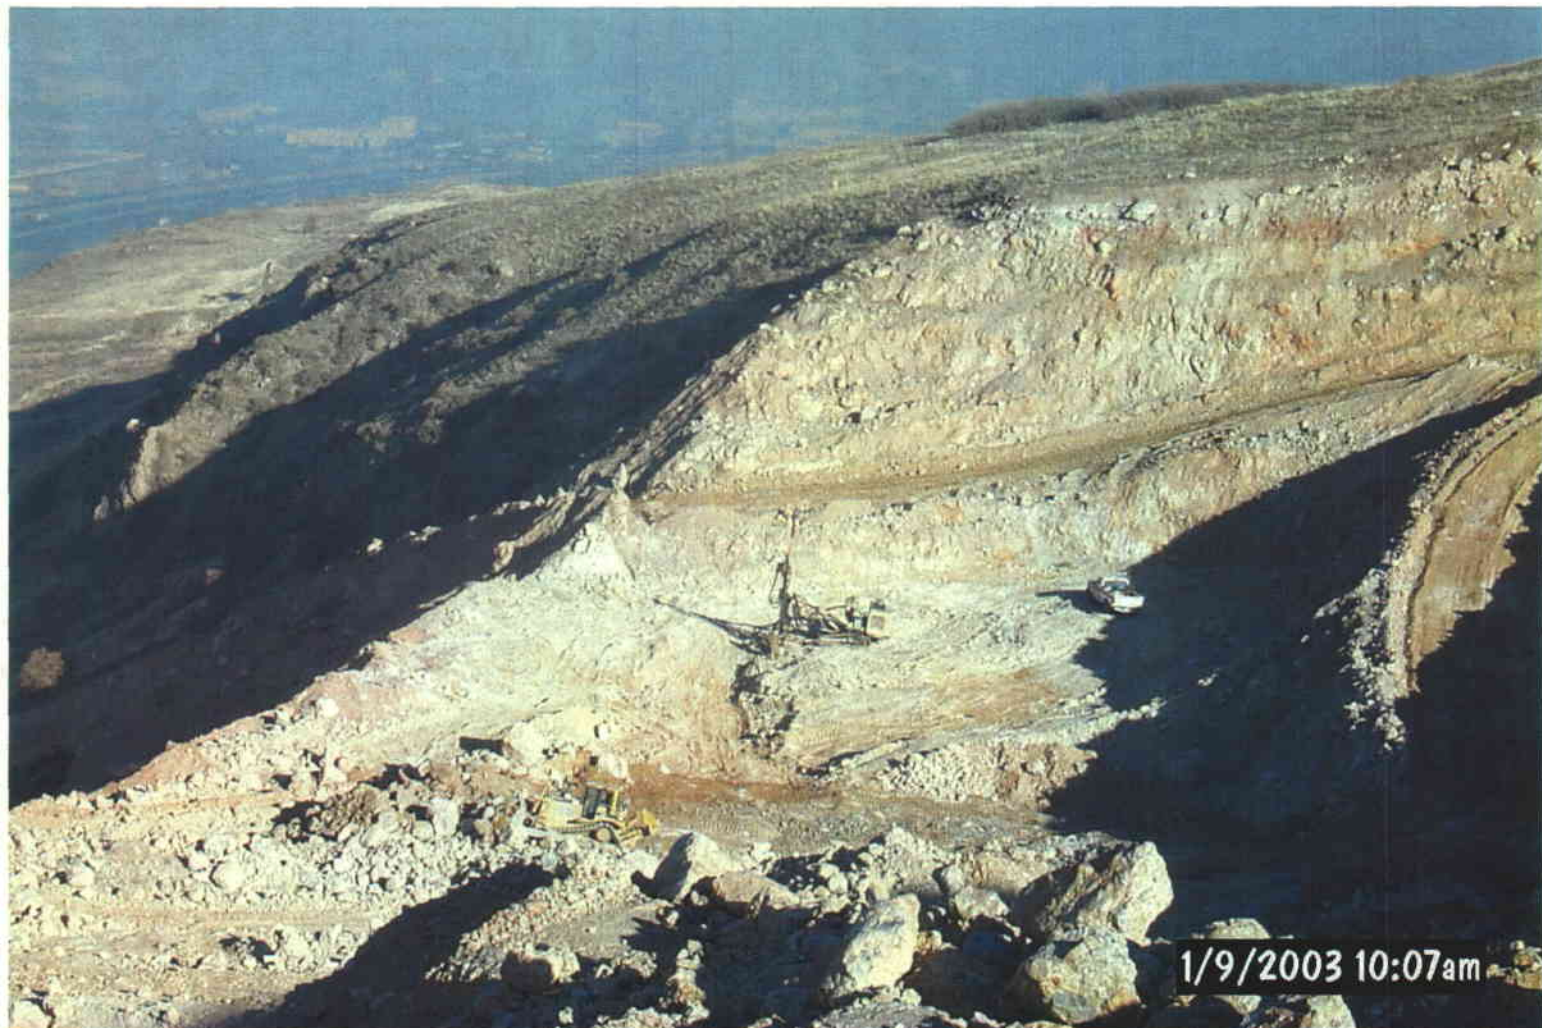
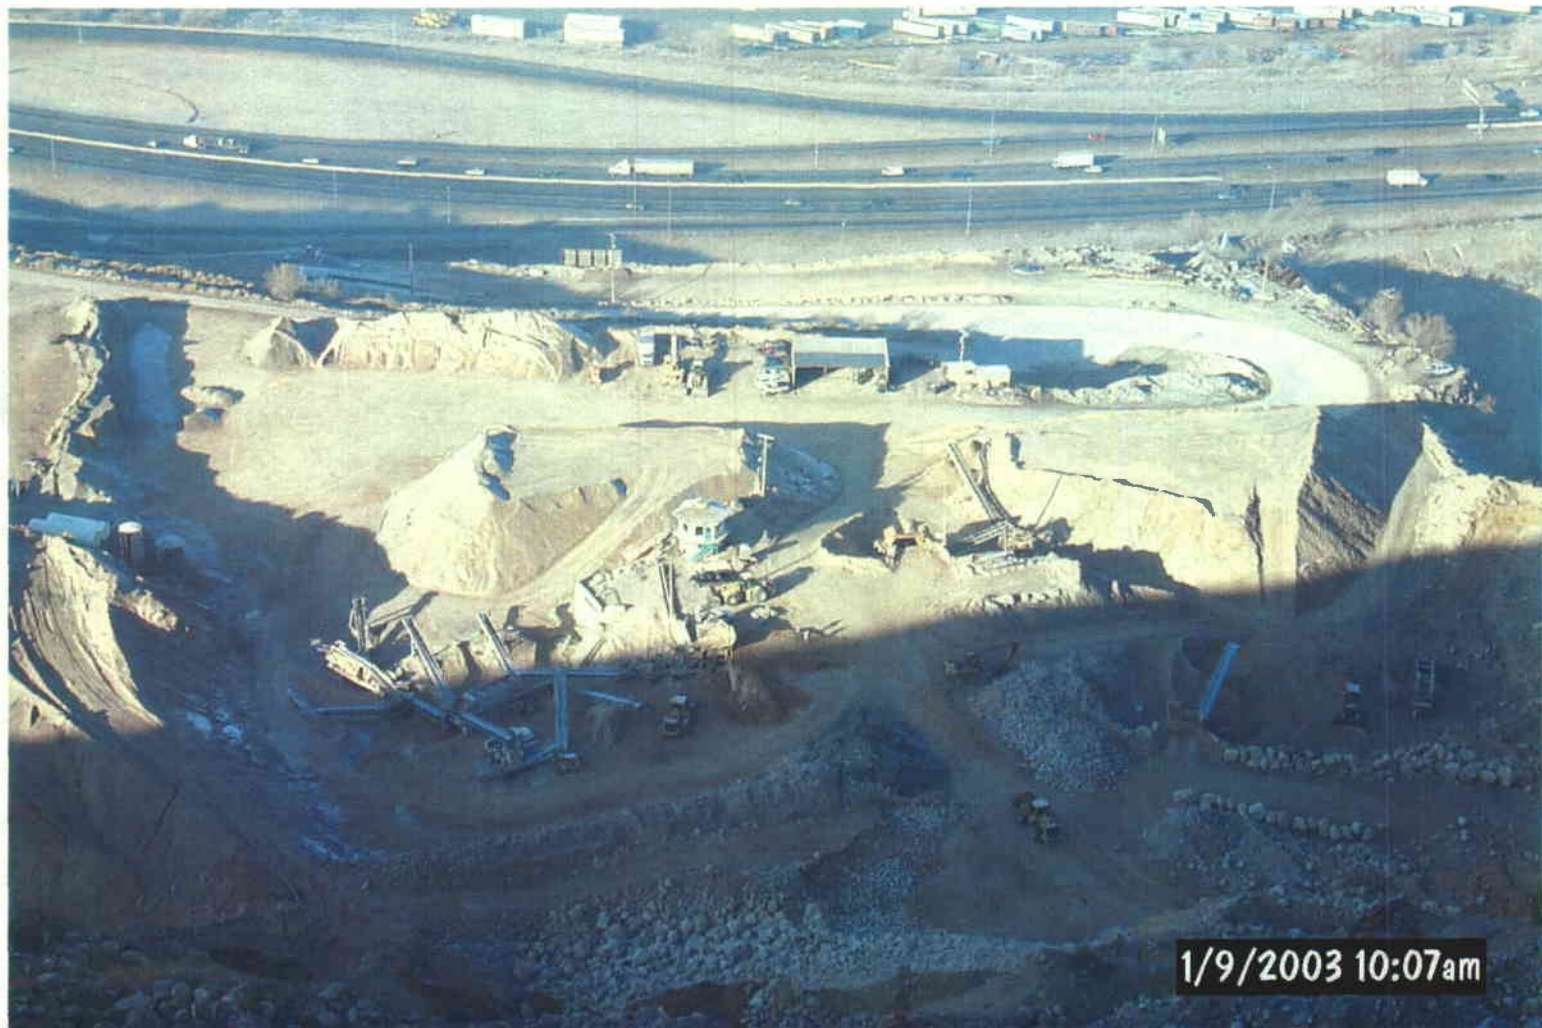
Because the upper working benches were not accessible from the quarry, Mr. Baker and I then drove to an area adjacent to the pit and hiked into the upper working areas of the quarry. A barbed wire fence surrounded the area around the upper quarry, and a sign on the fence read "Danger - Explosives - Keep Off." Operating on this upper bench was a D8 or D9 cat and a small track-mounted drill. There was also a pickup truck parked adjacent to the drill. The drill was working to complete a pattern of holes. These holes were laid out in a manner that lead us to conclude that they were being drilled for the purpose of blasting the underlying bedrock material.

Pictures of the upper quarry area were taken and are attached to this report.

The floor of the upper quarry area appears to be solid bedrock with no alluvial overburden material remaining. In order to continue to remove rock materials from this location, Lakeview will need to drill and blast the bedrock.

As a result of our findings during this inspection, the conditional exemption designation for the Lakeview Quarry should be terminated. Lakeview Rock Products should be required to file all appropriate permitting information with the Division.
